**SERVICE
BULLETIN**

mazda

RX-7 (13B)

SUBJECT Filter for the Vent Solenoid Valve.

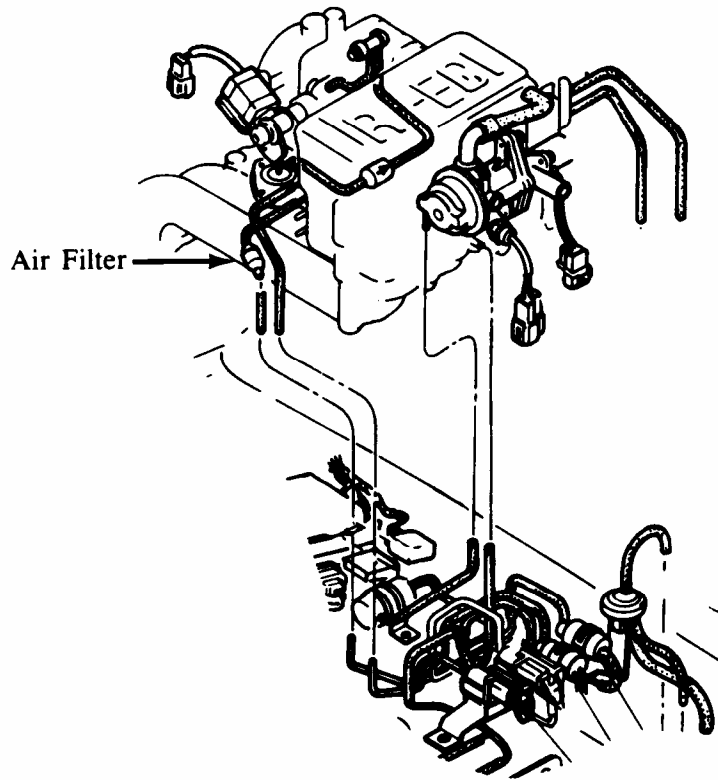
To prevent high idle speed or idle speed hunting caused by a sticking vent solenoid valve, an air filter has been installed between the dynamic chamber and vent solenoid valve since the production date of March, 1985.

The air filter kit has also been established as a service part for the vehicle produced prior to this production change. If high idle speed or idle speed hunting is caused by the malfunction of the vent solenoid valve, install the air filter and attach the vacuum diagram lable at the same time of replacing the vent solenoid valve. See Service Bulletin Category 4, 008/84 for additional information.*

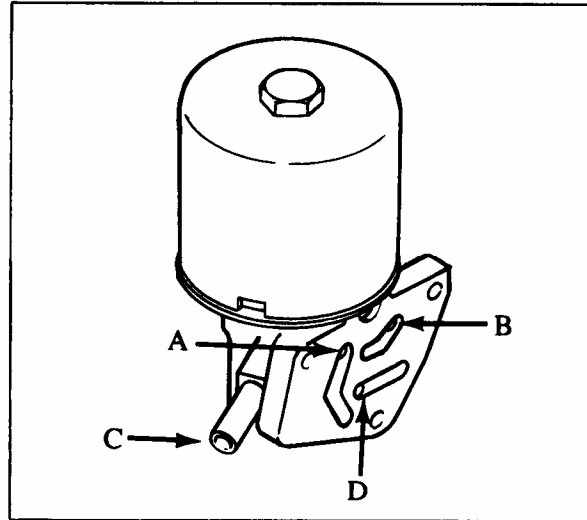
An altitude compensator valve is attached to the 1981-1985 RX-7 carburetor to supply additional air into the carburetor at high altitudes (between 1640-4920 ft) in order to lean the mixture for better driveability. If the altitude compensator remains open at low altitudes, the following driveability problems may occur:

- Lack of acceleration, hesitation on acceleration
- No power under load
- Engine stumble, surge or bucking below approximately 3000 rpm
- Rough idle

1. Remove the altitude compensator valve.
2. Blow through the valve from port A and B. Check that:
 - Above 4920 feet - air into port A exits from port D and air into port B exits from port C.
 - Below 1640 feet - air does not pass.If not, replace the altitude compensator valve.

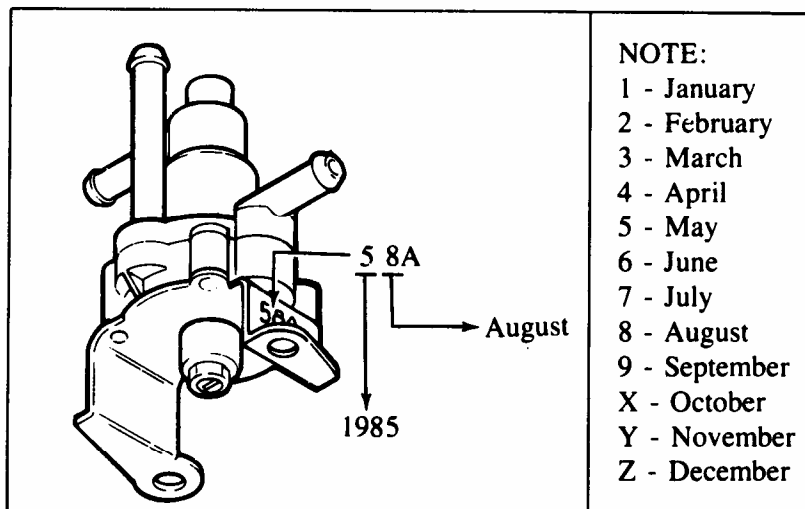
Modified check & cut valves are available as service parts for 1981-1985 RX-7 and 1982-1985 GLC in order to prevent a whistle noise. The whistle noise tends to occur from the check & cut valve at high temperature and low fuel level, and can be heard from the rear of the vehicle.

The part numbers of 8341-42-910 for RX-7/GLC and BA01-42-910 for GLC have not been changed, however, a modified check & cut valve can be distinguished from an unmodified one by the production date stamped on the bracket as shown.

If a customer complains about the whistle noise, replace the check & cut valve with the modified one.

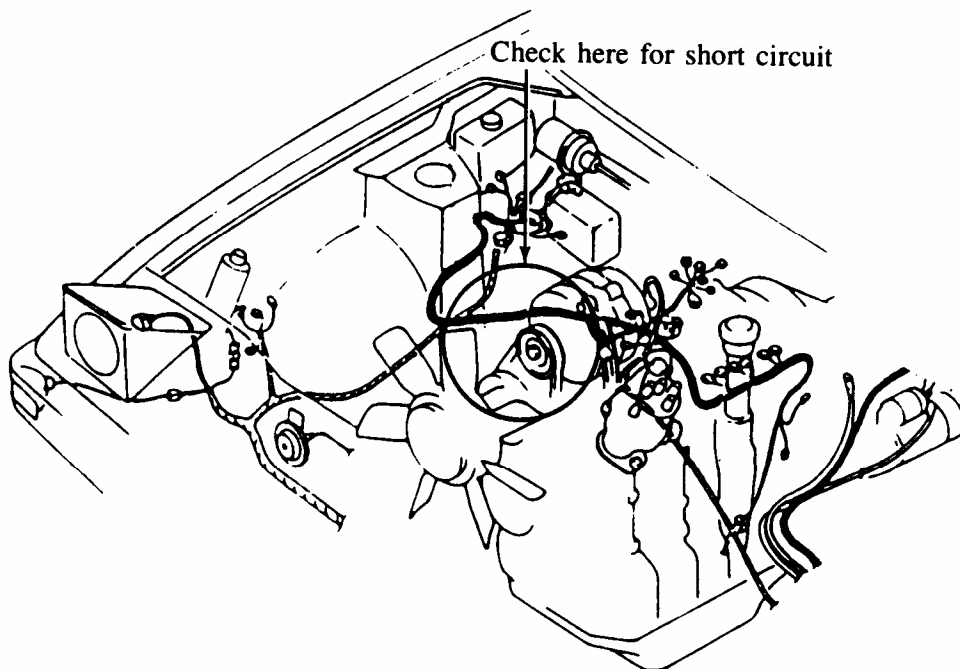
If the "ENGINE" fuse blows, preventing the engine from starting, the problem may be due to an electrical short circuit in the engine harness. Carefully inspect and repair the engine harness, if necessary, in the area of the thermostat and air hose to the air cleaner.

To prevent short circuiting, the clearance between the engine harness and the air hose to the air cleaner has been increased since the production of October 1, 1984.

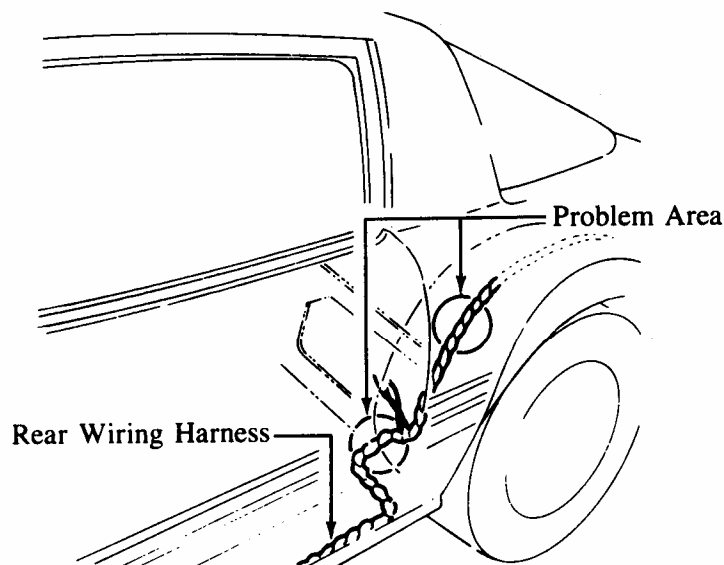
Many electrical problems and blown fuses may be caused by a short circuit in the rear harness. The rear harness may be cut by a sharp metal edge where the harness is routed over the inner wheel well. Some electrical problems reported from the field include:

If this problem is found, repair the rear harness as necessary and wrap the harness with foam rubber to protect the harness from contact with the sharp metal edges in the area shown.

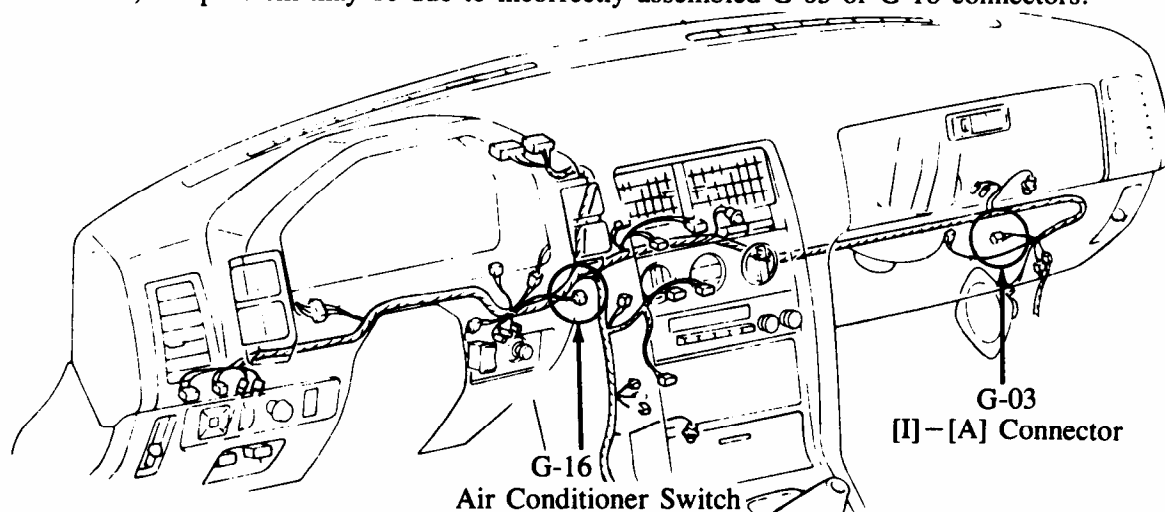
Some air conditioner kits manufactured by Lone Star Manufacturing Company may contain incorrectly assembled harness connectors.

If the indicator light on the air conditioner switch does not illuminate, or illuminates dimly after installation, the problem may be due to incorrectly assembled G-03 or G-16 connectors.

1. Check that the G-03 accessory connector (A) is assembled correctly as viewed from the harness side of the connector. If not, remove the incorrect terminals and reassemble according to the connector diagram.
2. Check that the G-16 accessory connector (A) is assembled correctly as viewed from the harness side of the connector. If not, remove the incorrect terminals and reassemble according to the connector diagram.
