RX-7

Battery Clamp Bolt & Nut.

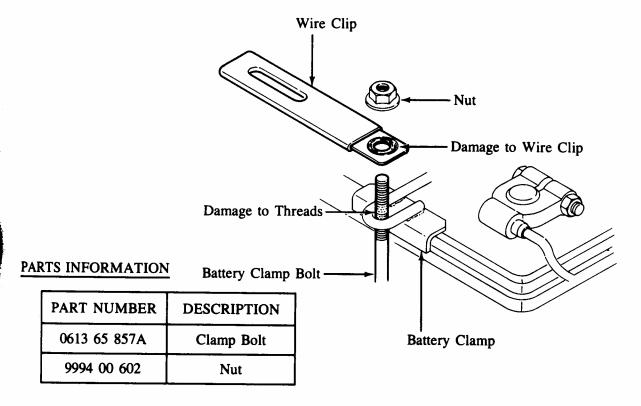
During installation of the battery clamp rod and nut, it is possible for wire clip to become pinched in the threads on the clamp bolt, resulting in the nut binding on the clamp rod.

- 1. Carefully remove the nut from the battery clamp bolt.
- 2. Use a die to repair the threads on the clamp bolt.
- 3. Install a small washer on top of the wire clip to prevent damage to the threads on the clamp bolt during reinstallation.
