ALL MODELS

SUBJECT Turn Signal Switch Cancel Cam.DESCRIPTION

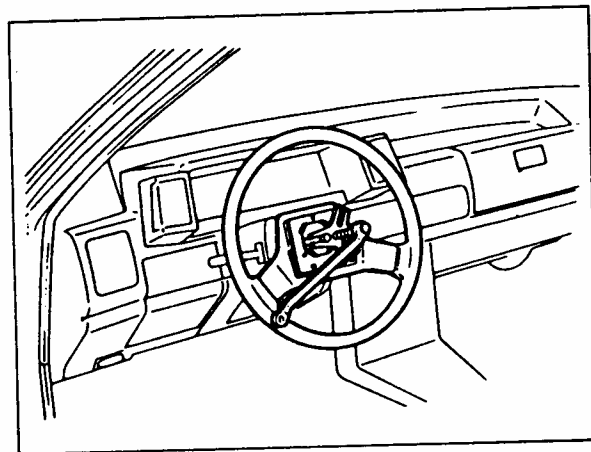
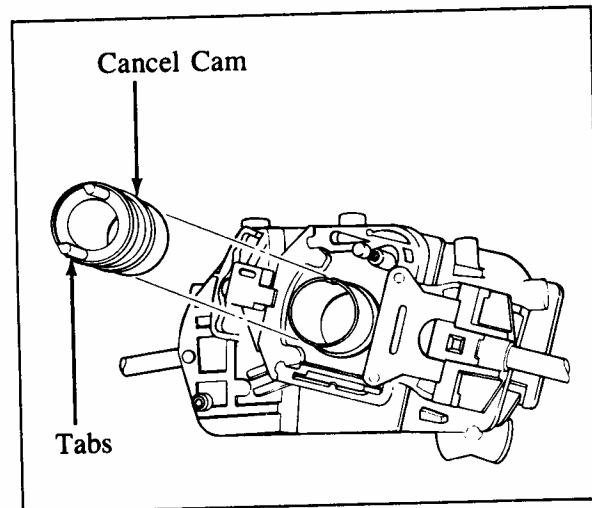
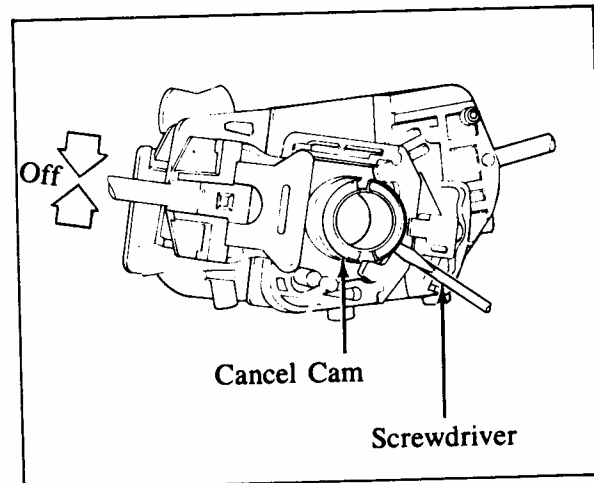
If the turn signal switch does not cancel, the most probable cause is a broken cancel cam. The cancel cam is available separately and can be replaced as shown below.

3. Inspect the cancel cam. If the tabs are broken off the cancel cam, the combination switch can be repaired by replacing the cancel cam.

4. Place the turn signal in the "OFF" position.
5. Carefully pry the cancel cam from the combination switch using a screwdriver.
6. Install the new cancel cam to the combination switch.

NOTE: It is not necessary to apply additional grease to the cancel cam.

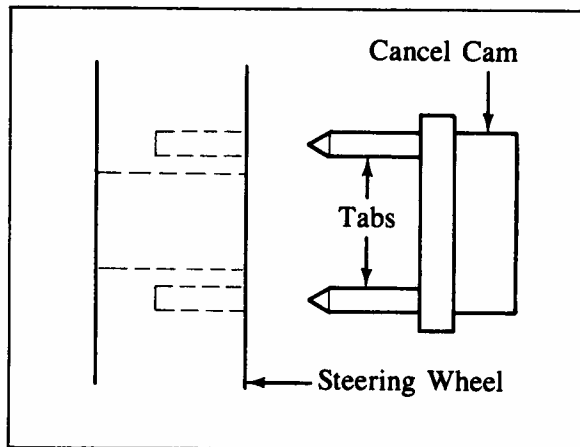
NOTE: The cancel cam will be broken if the tabs are not aligned with the holes in the steering wheel.

7. Align the tabs of the cancel cam with the holes in the steering wheel and install the steering wheel.

8. Install the steering wheel and torque the retaining nut to specification.

RX-7, 626, GLC: 29-36 ft-lb
B2000, B2200: 22-29 ft-lb
