1979-1984 RX-7

SUBJECT Engine Harness.DESCRIPTION

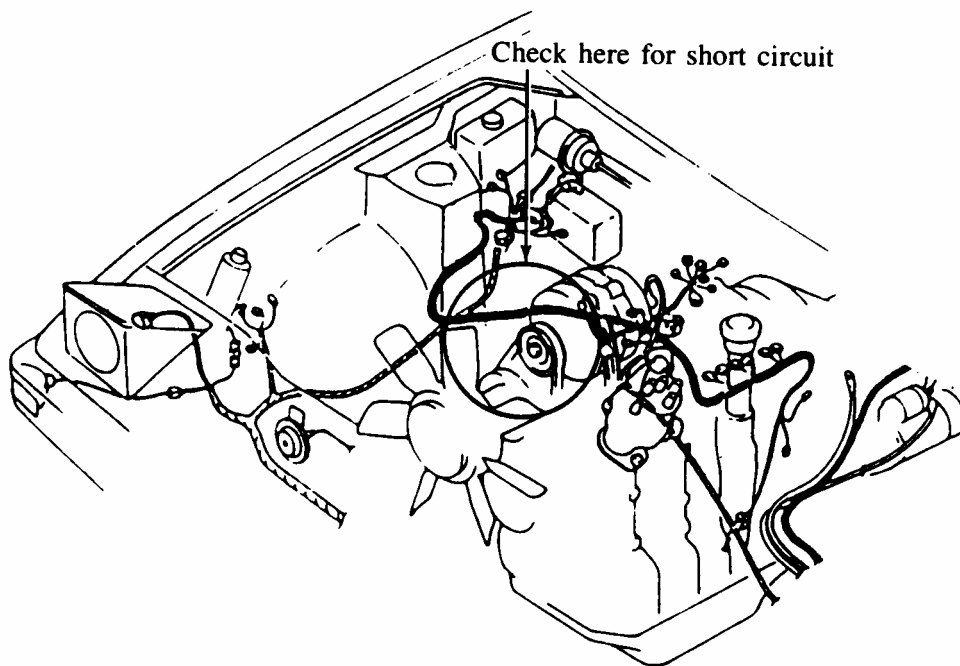
If the "ENGINE" fuse blows, preventing the engine from starting, the problem may be due to an electrical short circuit in the engine harness. Carefully inspect and repair the engine harness, if necessary, in the area of the thermostat and air hose to the air cleaner.

To prevent short circuiting, the clearance between the engine harness and the air hose to the air cleaner has been increased since the production of October 1, 1984.
