1979-1985 RX-7

SUBJECT Rear Harness.

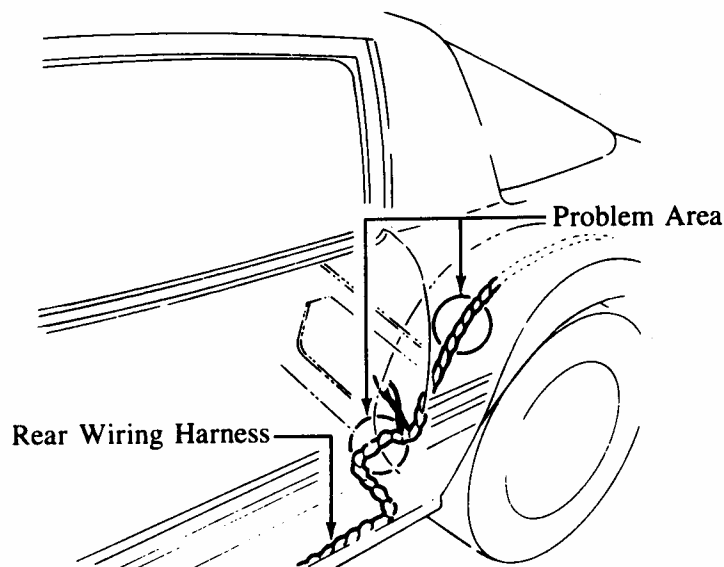
Many electrical problems and blown fuses may be caused by a short circuit in the rear harness. The rear harness may be cut by a sharp metal edge where the harness is routed over the inner wheel well. Some electrical problems reported from the field include:

If this problem is found, repair the rear harness as necessary and wrap the harness with foam rubber to protect the harness from contact with the sharp metal edges in the area shown.
