RX-7

SUBJECT Air Conditioner Indicator Light.

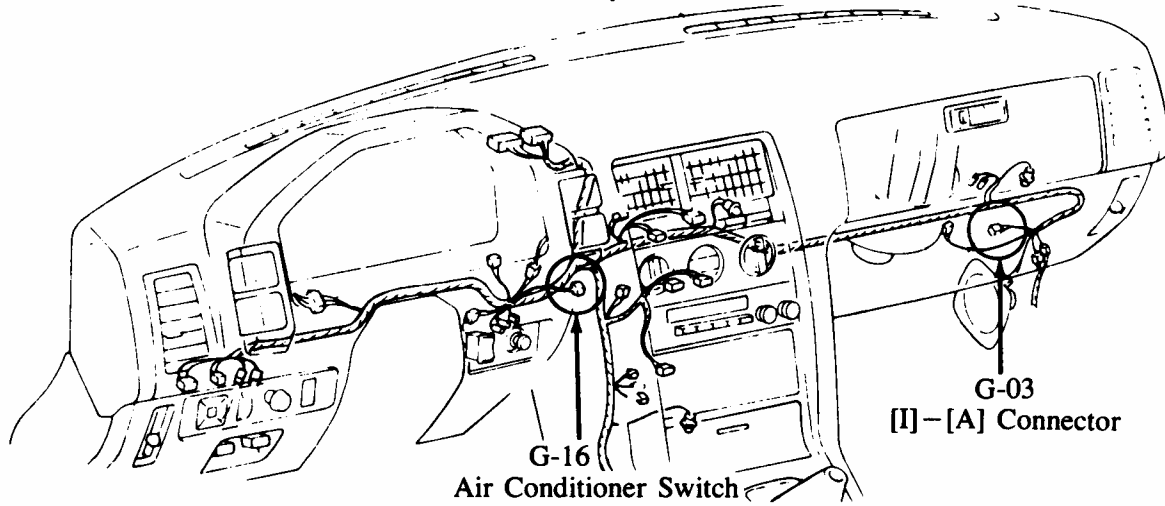
Some air conditioner kits manufactured by Lone Star Manufacturing Company may contain incorrectly assembled harness connectors.

If the indicator light on the air conditioner switch does not illuminate, or illuminates dimly after installation, the problem may be due to incorrectly assembled G-03 or G-16 connectors.

1. Check that the G-03 accessory connector (A) is assembled correctly as viewed from the harness side of the connector. If not, remove the incorrect terminals and reassemble according to the connector diagram.
2. Check that the G-16 accessory connector (A) is assembled correctly as viewed from the harness side of the connector. If not, remove the incorrect terminals and reassemble according to the connector diagram.
