**SERVICE
BULLETIN**

mazda

RX-7 (13B)

SUBJECT Filter for the Vent Solenoid Valve.

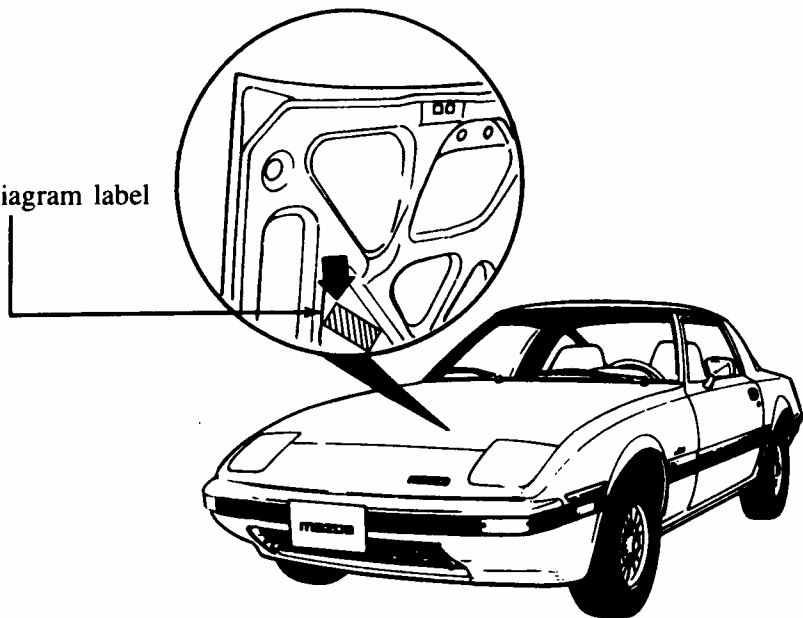
To prevent high idle speed or idle speed hunting caused by a sticking vent solenoid valve, an air filter has been installed between the dynamic chamber and vent solenoid valve since the production date of March, 1985.

Attach vacuum diagram label

The air filter kit has also been established as a service part for the vehicle produced prior to this production change. If high idle speed or idle speed hunting is caused by the malfunction of the vent solenoid valve, install the air filter and attach the vacuum diagram lable at the same time of replacing the vent solenoid valve. See Service Bulletin Category 4, 008/84 for additional information.*

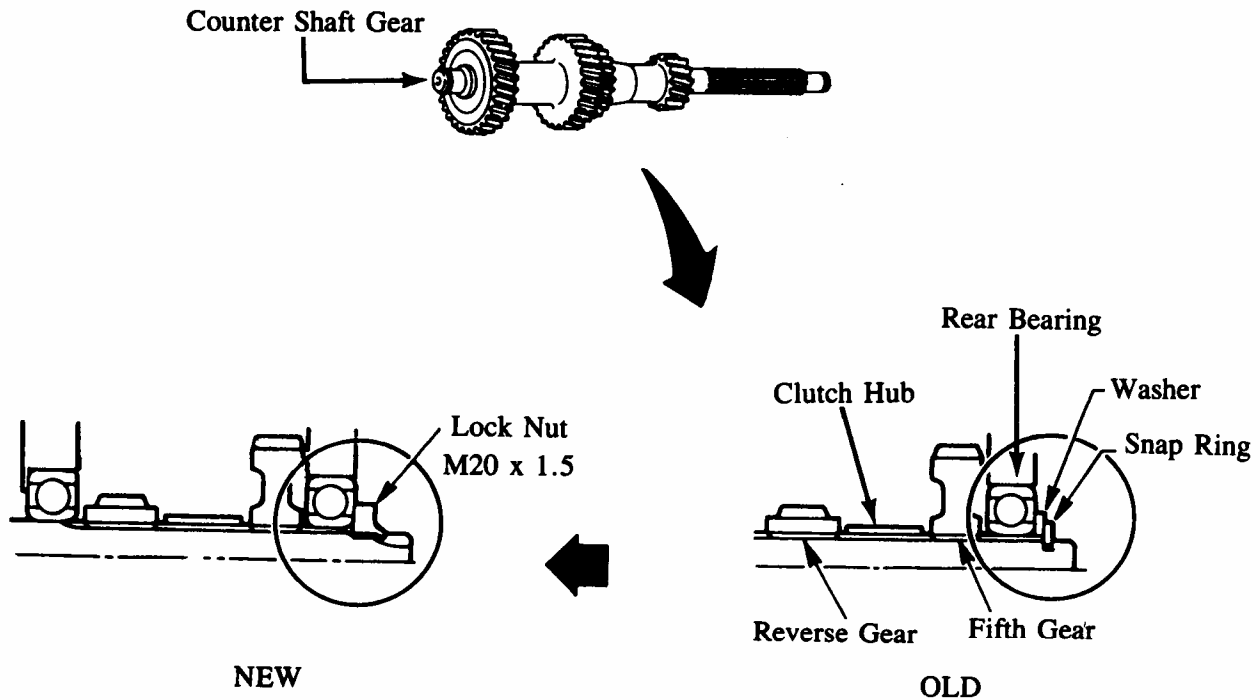
In order to retain the rear bearing on the counter shaft gear more securely, the snap ring has been replaced by a lock nut.

- Tighten the lock nut to: 94-145 ft-lb
127-196 N-m
13-20 kg-m

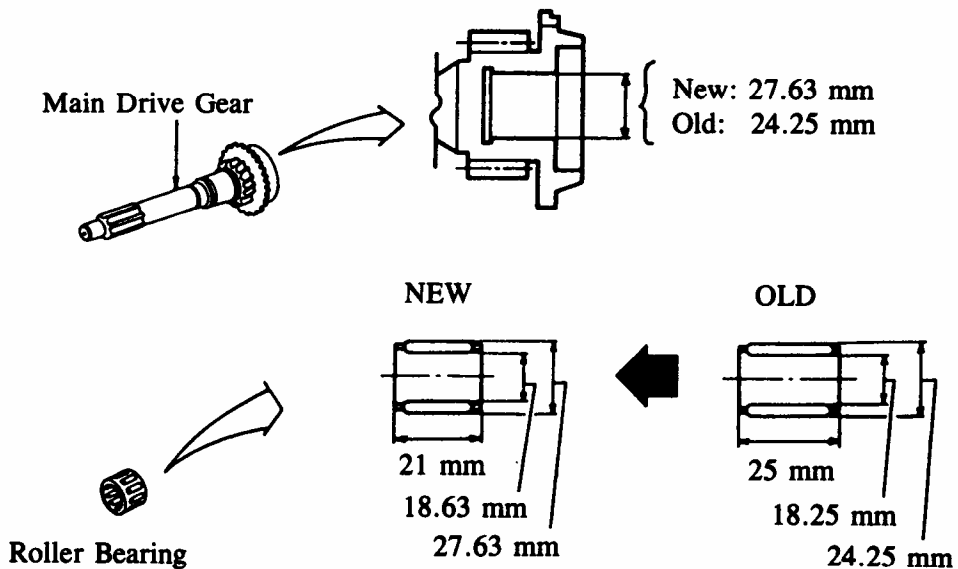
1. The roller bearing has been enlarged and the recess in the main drive gear has been enlarged to accept the new roller bearing.

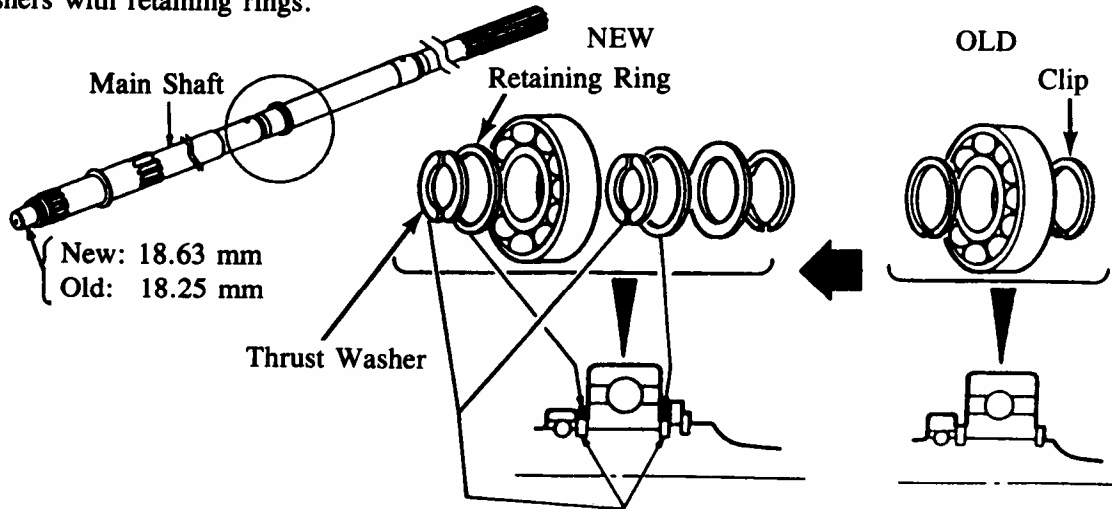
2. The method of retaining the bearing on the main shaft has been changed from clips to thrust washers with retaining rings.

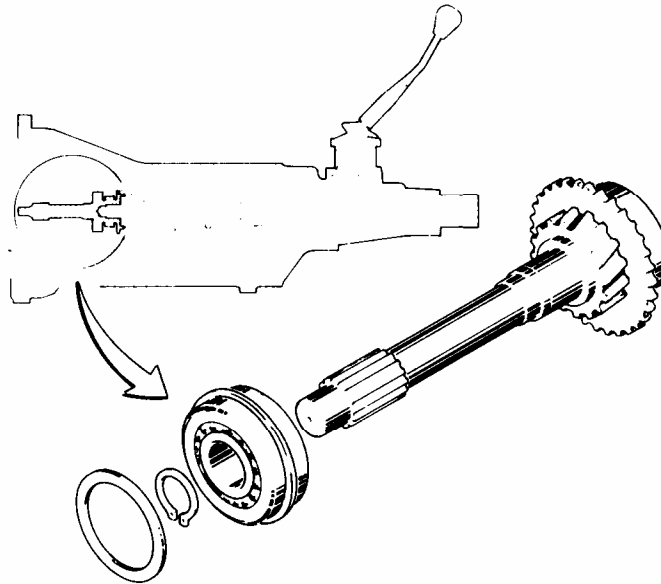
The ball bearing of the main drive gear has been changed to a specially heat treated bearing in order to further improve the durability of the transmission.

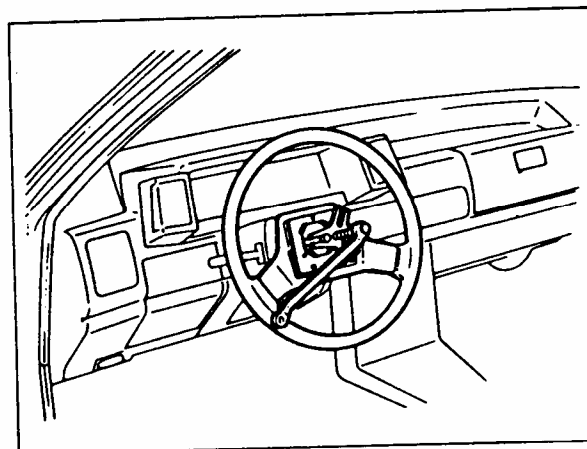
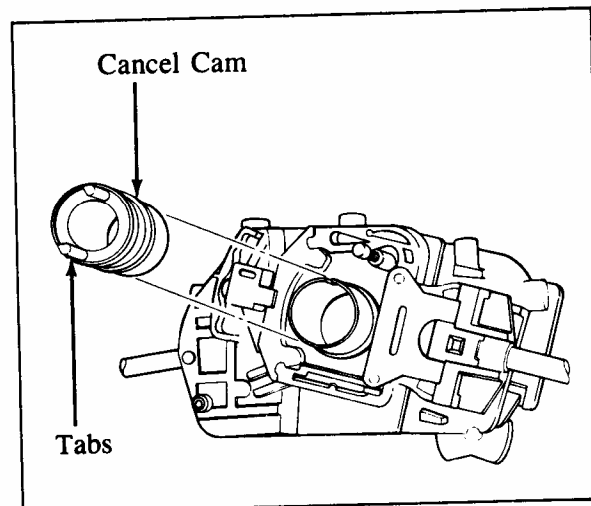
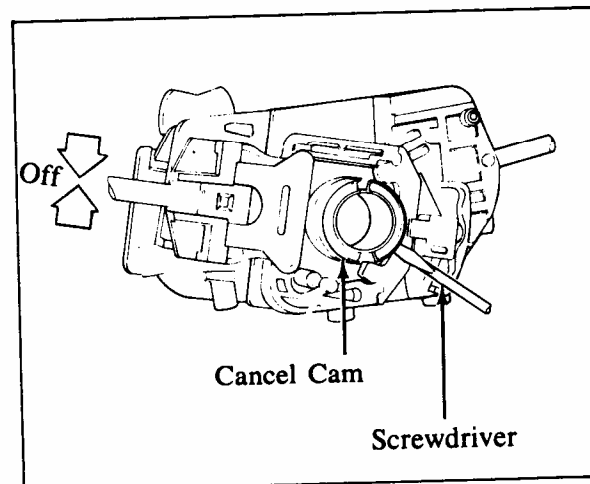
If the turn signal switch does not cancel, the most probable cause is a broken cancel cam. The cancel cam is available separately and can be replaced as shown below.

3. Inspect the cancel cam. If the tabs are broken off the cancel cam, the combination switch can be repaired by replacing the cancel cam.

4. Place the turn signal in the "OFF" position.
5. Carefully pry the cancel cam from the combination switch using a screwdriver.
6. Install the new cancel cam to the combination switch.

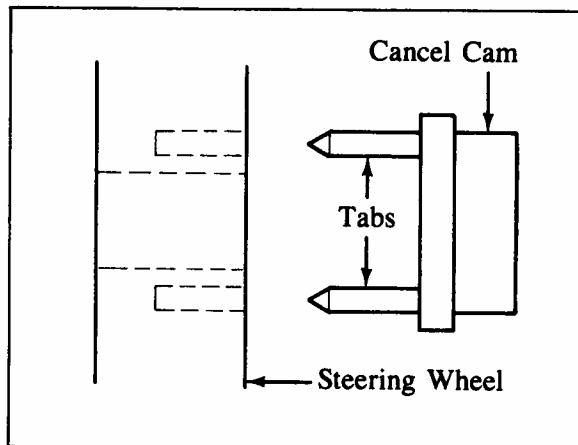
NOTE: The cancel cam will be broken if the tabs are not aligned with the holes in the steering wheel.

7. Align the tabs of the cancel cam with the holes in the steering wheel and install the steering wheel.

8. Install the steering wheel and torque the retaining nut to specification.

RX-7, 626, GLC: 29-36 ft-lb
B2000, B2200: 22-29 ft-lb

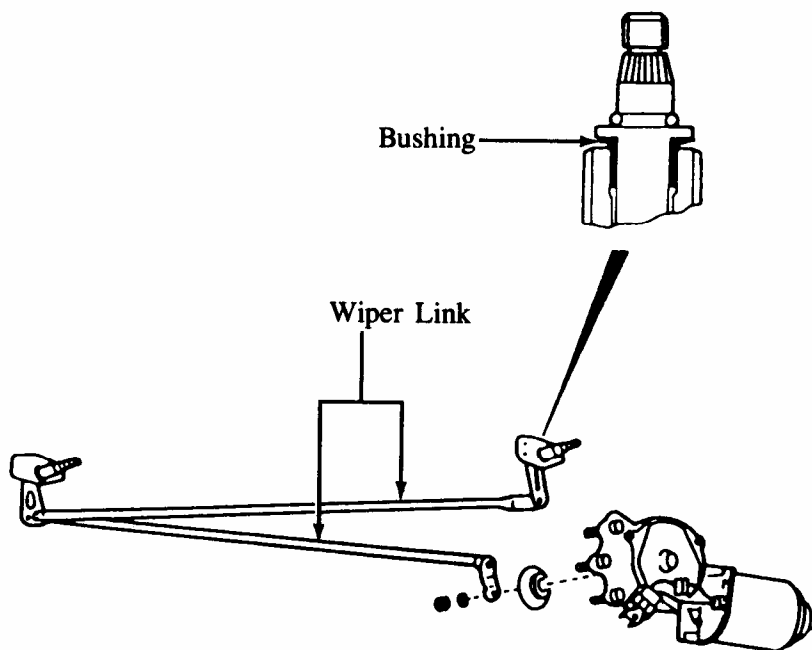
A new wiper link has been established as a service part. This new wiper link features a bushing as shown below.

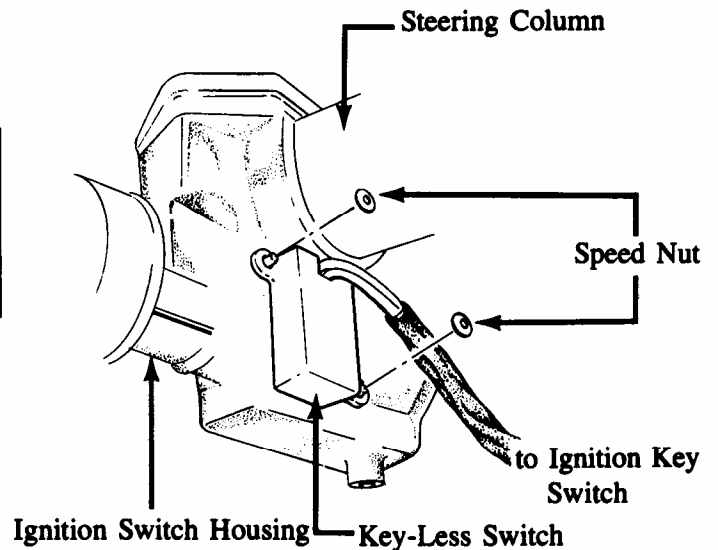
The speed nut for fixing the key-less switch to the ignition key cylinder housing has been established as a service part. If the replacement of the ignition key switch is necessary, please use the new speed nut to secure the key-less switch.

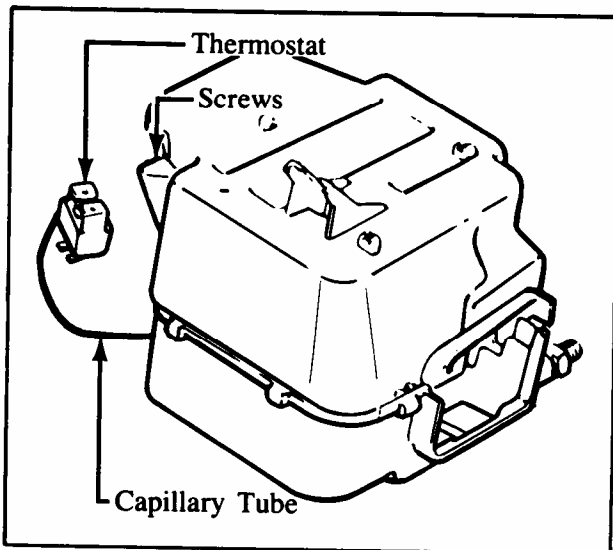
3. Remove the 2 screws securing the thermostat. Pull the thermostat approximately 1" away from the evaporator in order to provide access to the thermostat adjusting screw.

4. Turn the adjusting screw of the thermostat clockwise 90° from the original position.

Do not turn the adjusting screw more than 90°, otherwise the evaporator core will freeze, resulting in an adverse effect on the cooling performance.

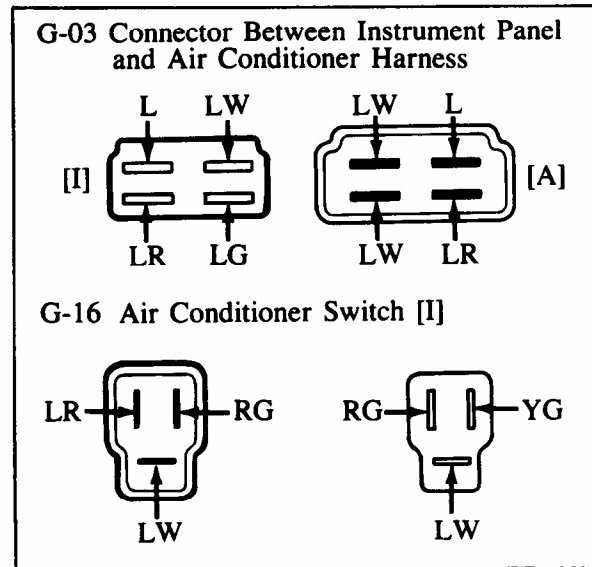
If the indicator light on the air conditioner switch does not illuminate, or illuminates dimly after installation, the problem may be due to incorrectly assembled G-03 or G-16 connectors.

1. Check that the G-03 accessory connector (A) is assembled correctly as viewed from the harness side of the connector. If not, remove the incorrect terminals and reassemble according to the connector diagram.
2. Check that the G-16 accessory connector (A) is assembled correctly as viewed from the harness side of the connector. If not, remove the incorrect terminals and reassemble according to the connector diagram.
